# Navajo Abandoned Uranium Mine

## Site Screen Report

## **New Liba Group AUM Site**

January 2011

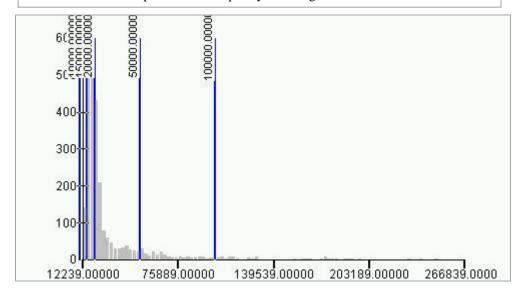
A total of 2,549 gamma radiation measurements were collected from the mine site, ranging from 12,239 cpm to 266,839 cpm. The measurements collected inside the open pit were found at levels ranging from approximately 30,000 cpm to 200,000 cpm, and at the waste piles surrounding the pit at a maximum level of approximately 265,000 cpm. The measurements are represented in Figures 1, 2, 3, and 4.

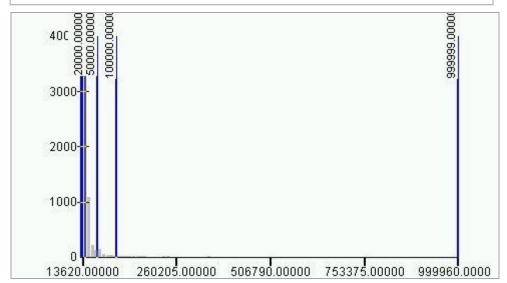
A total of 5,756 gamma radiation measurements were collected from the mine site, ranging from 13,620 cpm to 999,960 cpm. The measurements collected throughout the waste rock area were found at levels ranging from approximately 40,000 cpm to 1,000,000 cpm, at the exposed ore at a maximum level of approximately 250,000 cpm, and in the downstream drainages at a maximum level of approximately 25,000 cpm. The measurements are represented in Figures 1, 2, 5, and 6.

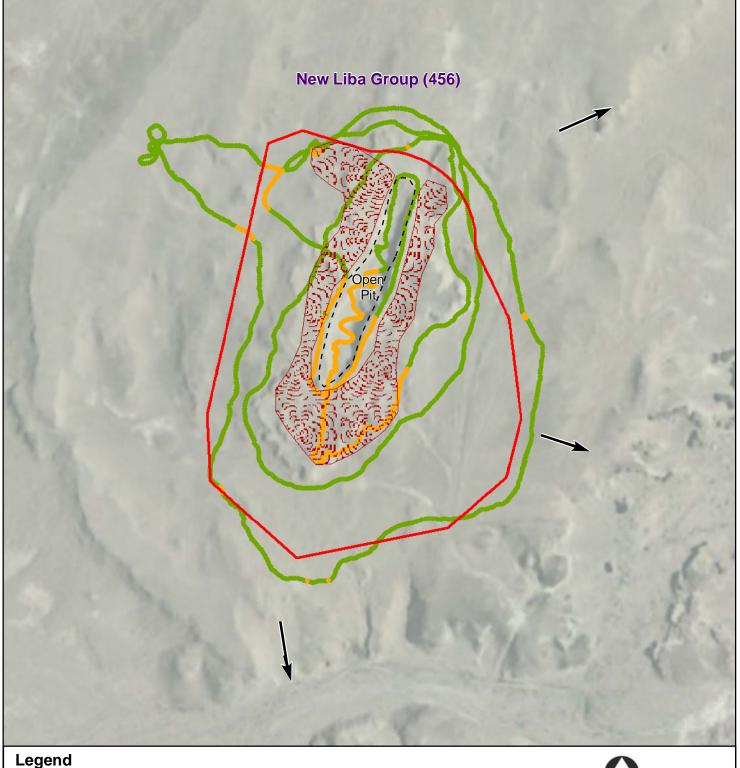
Figure 3 - Gamma Radiation Measurements, Above Two Times Background
New Liba Group (456)
Coconino County, Arizona

Waste piles throughout site, surrounding open pit, estimated 720' x 360' x 10'

Open pit area in center of site, approximately 30' x 320' x 30' deep

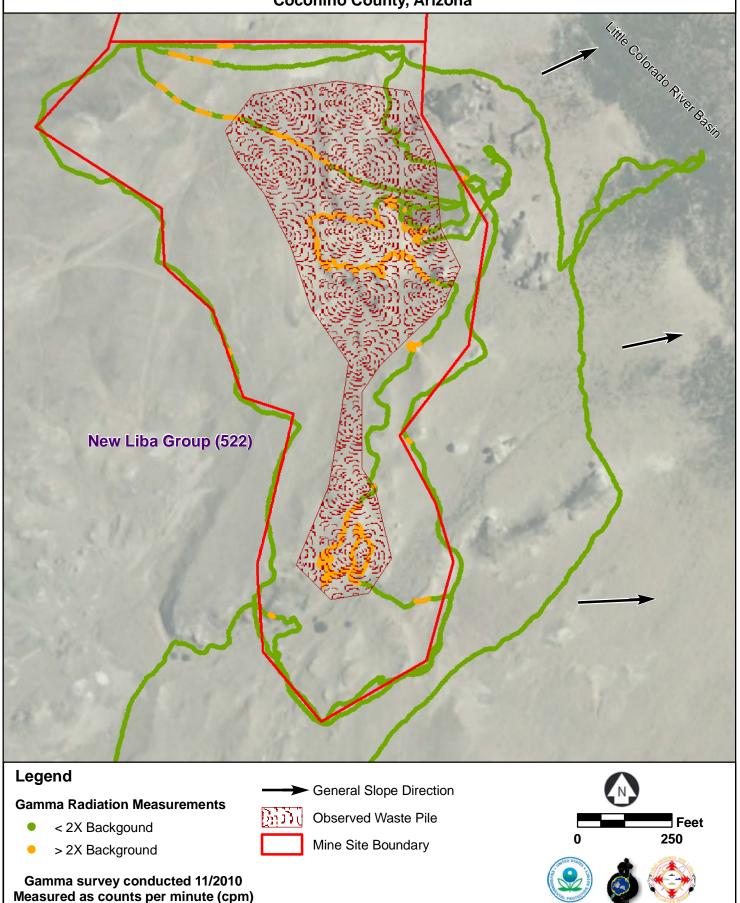
Figure 5 - Gamma Radiation Measurements, Above Two Times Background
New Liba Group (522)
Coconino County, Arizona

Majority of site is one large waste/workings pile, possible rim strip operation, estimated size 500' x 2,000' x 5'
